DETERMINATION OF BEAM ALIGNMENT AND CONGRUANCE OF RADIATION FIELD AND LIGHT AS PART OF QUALITY CONTROL IN TERTIARY HOSPITALS IN YOLA, ADAMAWA STATE, NIGERIA.

*Umaru, A.,² Odoh, E. O.,¹ Isa, S.,³ Muhammad, I.² and Shem. L. S.²

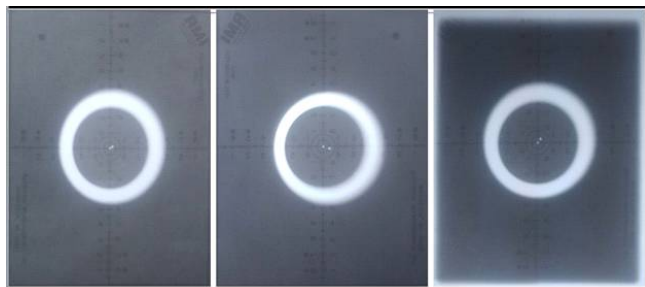
Figure 2; Beam Alignment and Congruency for machines M-1, M-2 and M-3

Figure 2 shows the radiographs obtained during the procedure for beam alignment and congruency for all the three machines the central point indicates the center of the beam while the other point indicates the degree of misalignment. If the x-ray beam is not coinciding with the light field, the radiation field may be shifted away from the area of clinical interest, which will contribute unnecessary dose to the patient. The misalignment reduces diagnostic image quality and leads to exposure of non-targeted areas and leads to cut off in anatomical area of interest and lead to repeat. It is caused by the shifts in the relative positions of the light bulb, reflecting mirror or anode focal spot. In the normal situation the beam alignment is not always be hundred percent accurate. But, if the beam alignment is less than 1.5° or in between 1.5° and 3° the perpendicularity (alignment) of the x-ray beam is in the acceptable limit. If it moves beyond 3°, it is not within the acceptable limit [6], based on the result presented in Fig. 2 above shows that machine M-1 and M-3 falls within the inner circle which is less than 1.5° while M-2 is on the inner circle which is 1.5° and were all within acceptable limits.
