## Evaluation of Beam collimation status as a Radiation Protection measure in Radiography practice in two Selected Hospitals in North-eastern Nigeria.

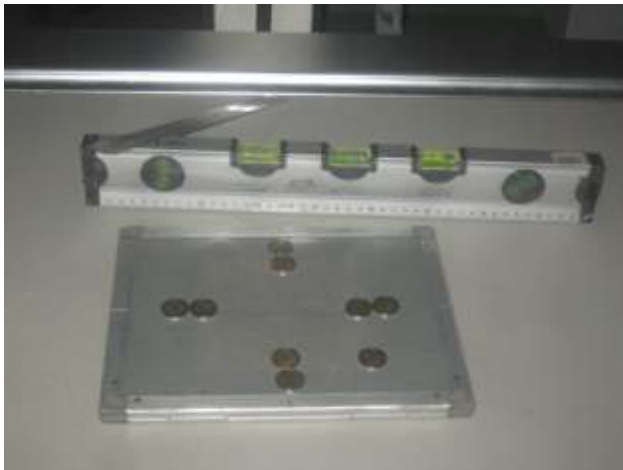
Figure 1: practical set up for light beam collimation test

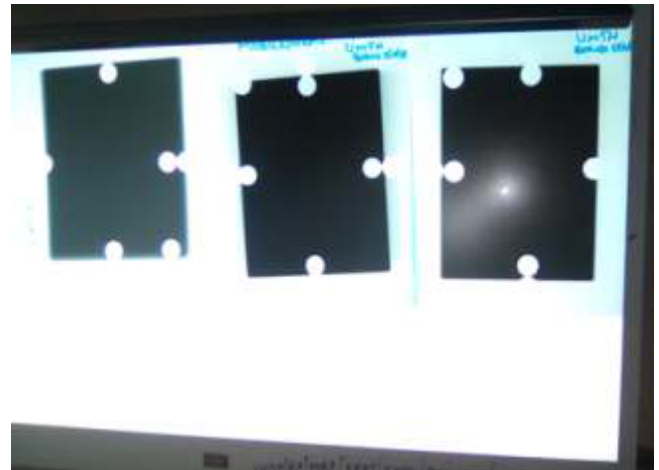
Figure 2: Radiograph for light beam collimation test
